# Kane Constructions Pty Ltd

## Parramatta NRL Centre of Excellence & Community Facility

### **Dust Monitoring Graphs**

01 Nov 2023 - 30 Nov 2023

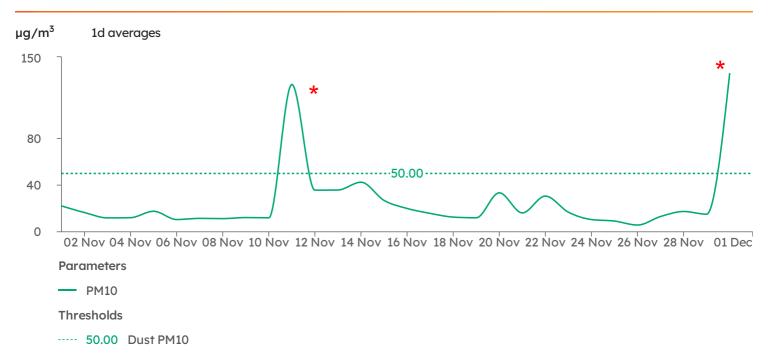
**Site Compound**

Dust spike occured out of hours, impacting daily reporting averages and was not caused by construction activities. On review with Site Hive tech support it appears the excedances were caused by moisture in the air.
