KANE

TREE PROTECTION MANAGEMENT PLAN

PARRAMATTA EELS CENTRE OF EXCELLENCE

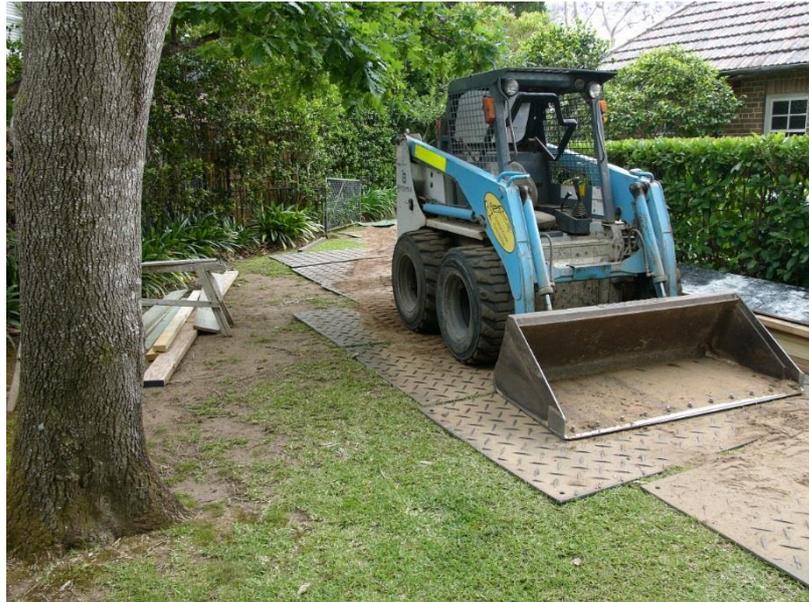
Figure 4 – Showing typical detail for truck mats.

10.7.1 Construction haul routes shall be confined to existing paved areas wherever possible. Where this is not feasible and construction haul routes or access for plant and equipment must traverse soft landscape areas within TPZs of [**any tree nominated for retention**], 20mm thick marine ply sheets or truck mats (such as Envirex Versadeck® access mats) (refer **Figure 4** shall be placed over the top of the ground surface to minimise compaction and disturbance of the underlying soil profile and root zone.

10.7.2 Ground protection shall be installed prior to any site works and maintained in good condition for the duration of the construction period. On completion of the works, ground protection shall be removed without damage or disturbance to the underlying soil profile.

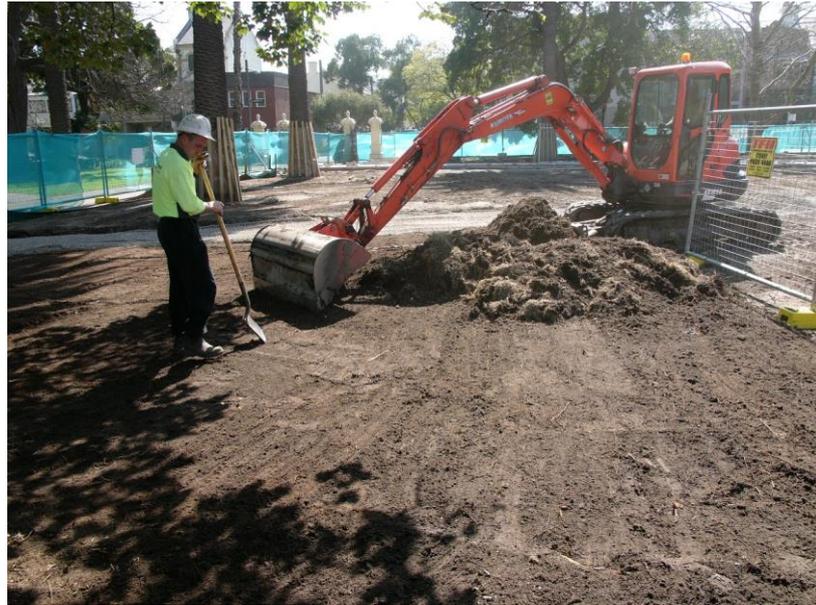
Figure 1 – Showing method for removal of residual surface vegetation from Tree Protection Zones following herbicide treatment and slashing.

Any residual vegetation (dead grass etc) may then be carefully scraped-off the surface using a small rubber tracked excavator with a broad sand bucket (i.e. without tynes/teeth), taking care to remove the minimum topsoil necessary (no more than 20mm deep) (refer to **Figure 1**). An observer shall be used to ensure that no woody surface roots of any trees are damaged during this process.

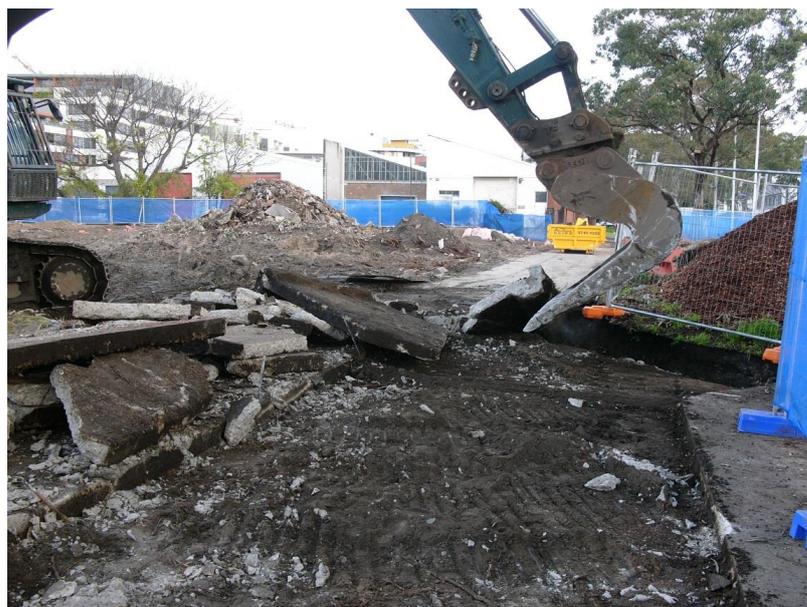
Figure 2 – Showing method for removal of concrete pavement, by carefully lifting sections and folding over the remaining paved surface.

Concrete pavements shall be demolished by breaking the slab into manageable sections (using a rock hammer or similar) and asphalt pavements shall be removed by breaking the topcoat into manageable pieces. The broken sections shall be carefully lifted and folded over the remaining paved surface to minimise disturbance and compaction of the underlying soil profile (refer to **Figure 2**). Special care shall be taken where underlying woody roots have lifted or displaced the pavement. Any plant or equipment used in demolition work shall operate within the footprint of existing paved areas and avoid traversing soft landscape areas. Where this is unavoidable, suitable ground protection shall first be installed in accordance with **Section 10.7**.

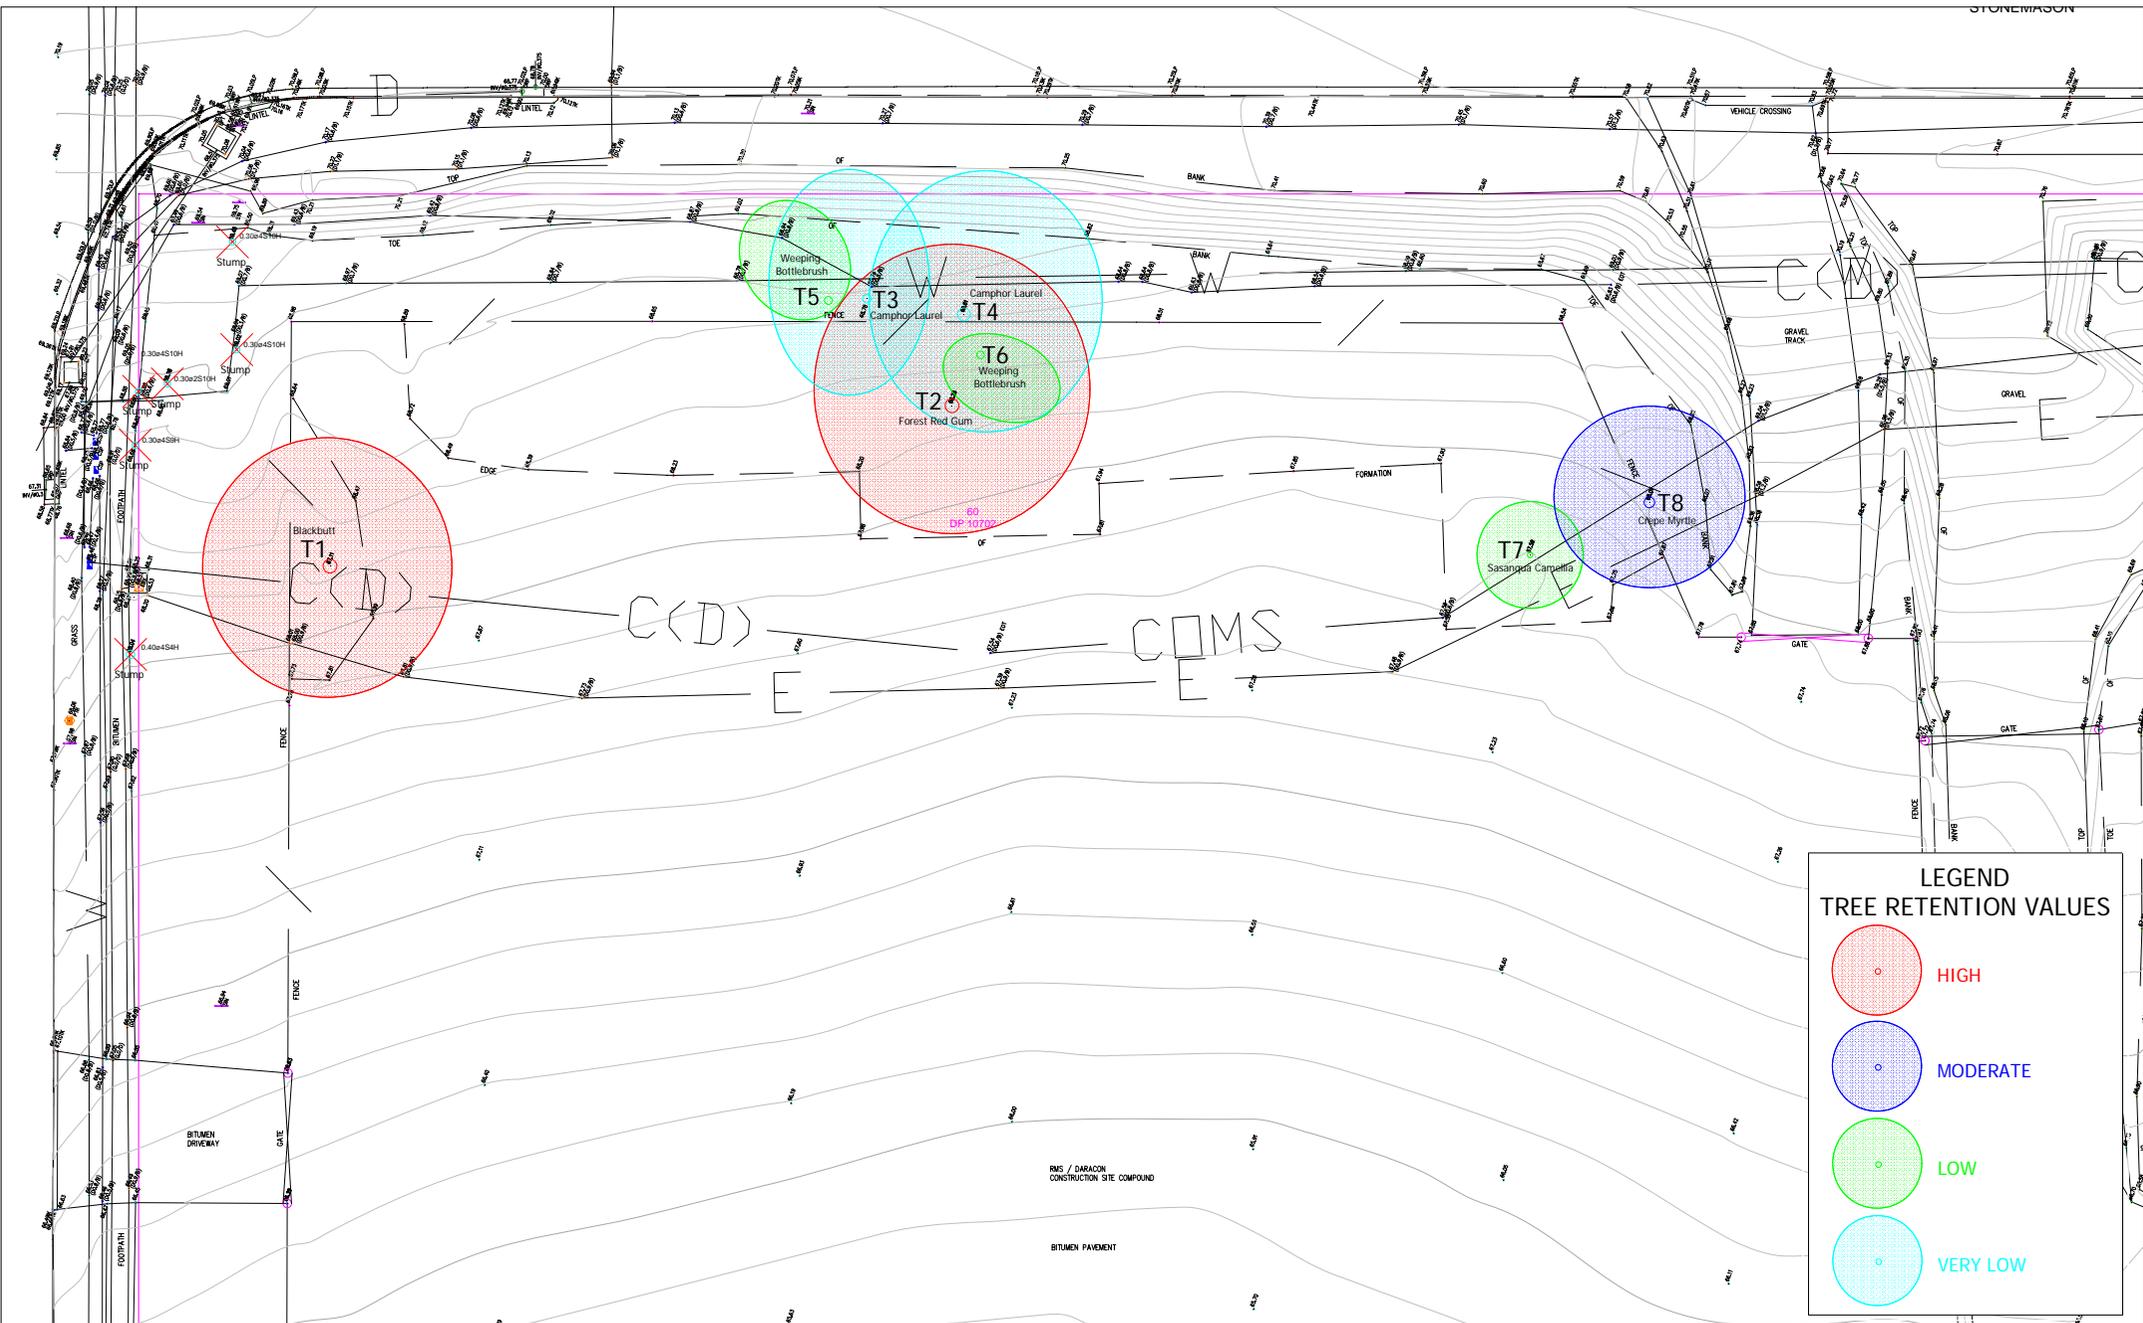
DWG No. T21-0507/01 [A]
SHEET 1
DATE: 07/05/2021

APPENDIX 5
 TREE LOCATION PLAN SHOWING
 TREE RETENTION VALUES
 Parramatta Eels Training Facility
 Memorial Avenue, KELLYVILLE, NSW

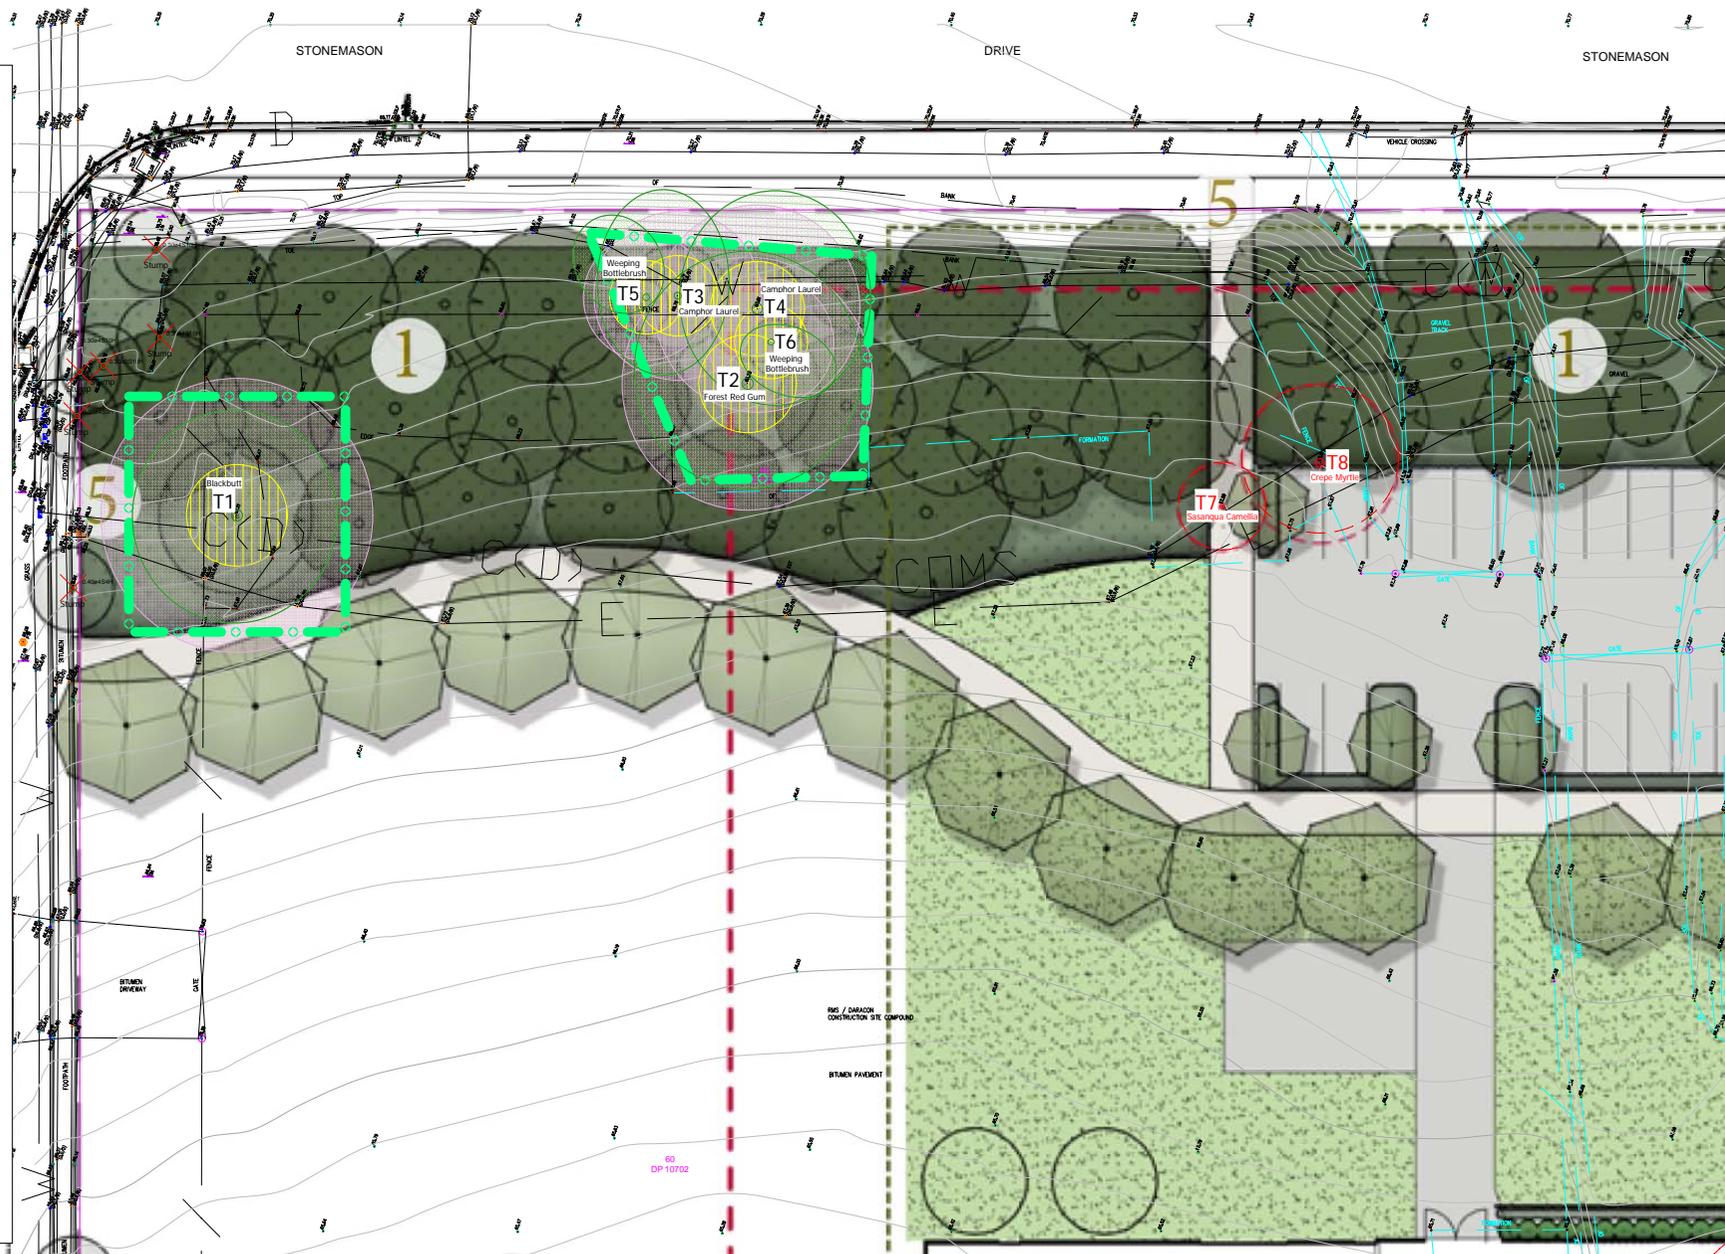
DWG No. T21-0507/02 [E]
 SHEET 1
 DATE: 24/01/2022

New development. All excavations for building foundations within TPZ's to be undertaken in accordance with Section 10.9
-

- 10.1.1 The following Tree Protection Measures should be read in accordance with the Tree Protection Plan (**Appendix 6**). The Tree Protection Plan (TPP) indicates the position of tree protection devices and other recommended measures to ensure the protection of trees within the site to be retained as part of the proposed development.

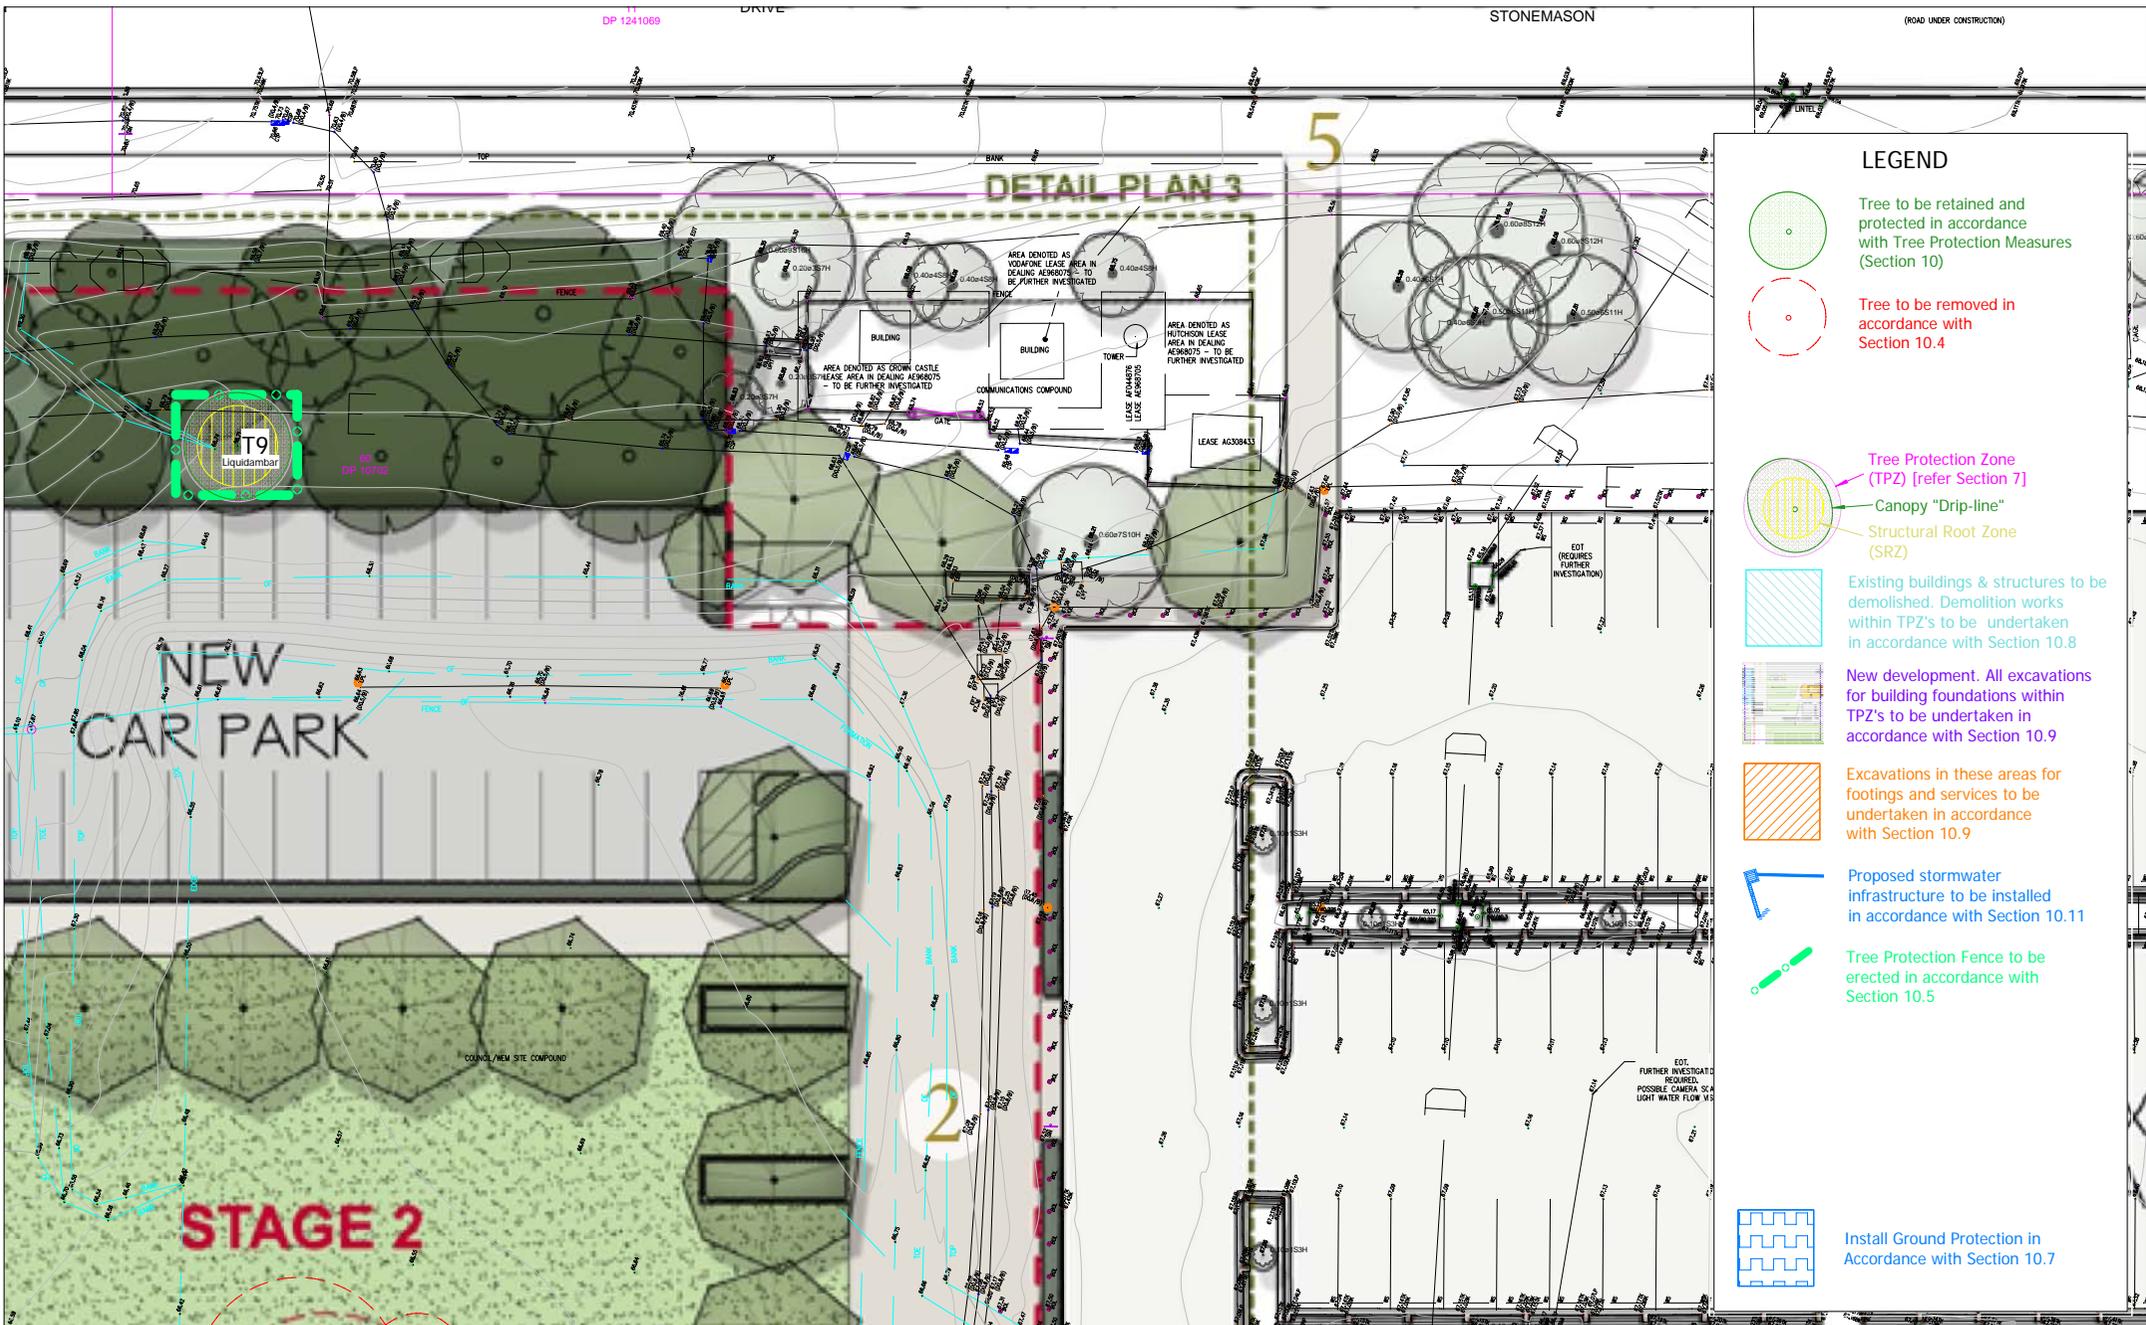
APPENDIX 6
TREE PROTECTION PLAN
 KELLYVILLE PARK
 6-8 Memorial Avenue, KELLYVILLE, NSW

Install Ground Protection in Accordance with Section 10.7
